DEVELOPMENT OF HIGH-STRENGTH  
ALUMINUM ALLOYS WITH IMPROVED  
STRESS-CORROSION RESISTANCE

J. Corey McMillan and Michael V. Hyatt  
The Boeing Company

TECHNICAL REPORT AFML-TR-68-148

June 1968

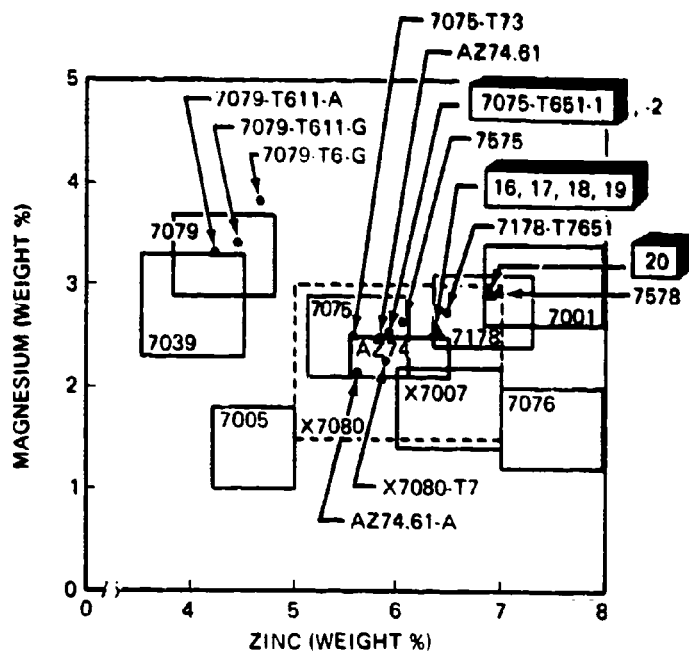
Figure 1. Chemical Compositions of Phase II and Comparison Alloys (Zn, Mg, and Cu)

A. Magnesium-Zinc

B. Magnesium-Copper

Alloys 7578 and 20 also have nearly identical compositions (Fig. 1) except for silver content. However, 7578 was overaged to a greater degree (T6 + 8 hr at 340°F) so that its strength was lowered below that of alloy 20 (T6 + 10 hr at 320°F). Another consideration is the fact that the 7578 specimens (as well as 7575 and 7178-T7651) were from 0.5-in.-thick material, compared to 0.25 in. for the Phase II alloys. A slower cooling rate would be expected for the 0.5-in. material, and could cause a drop of 1 to 4 ksi in mechanical properties (3).

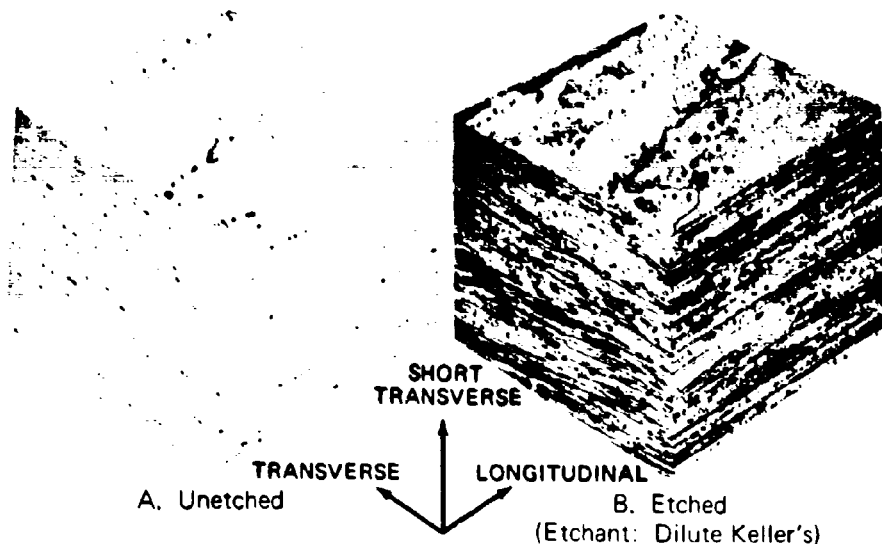
Figure 2. Microstructure of Alloy 16 (100x)

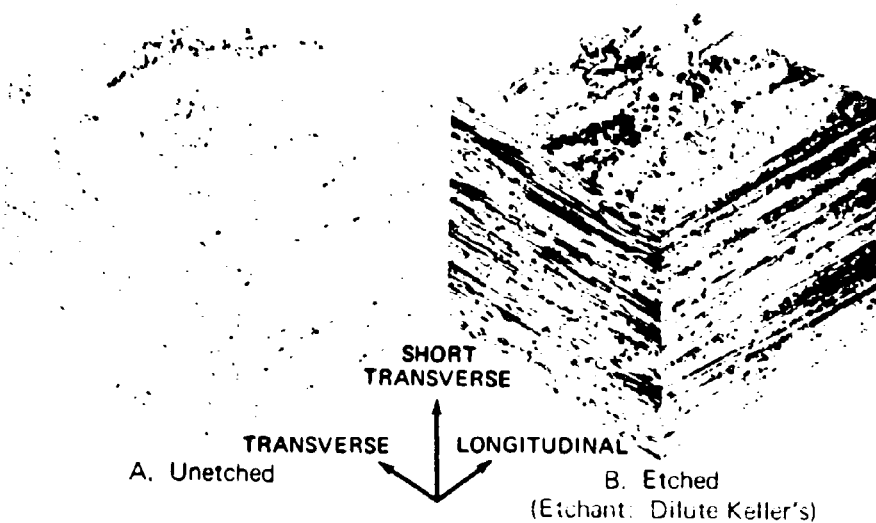
Figure 3. Microstructure of Alloy 17 (100x)

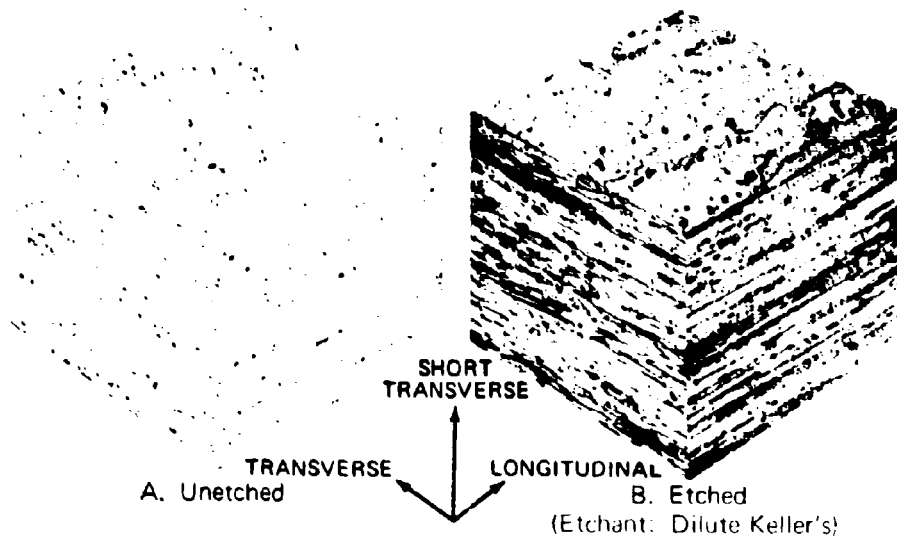
*Figure 6. Microstructure of Alloy 20 (100x)*

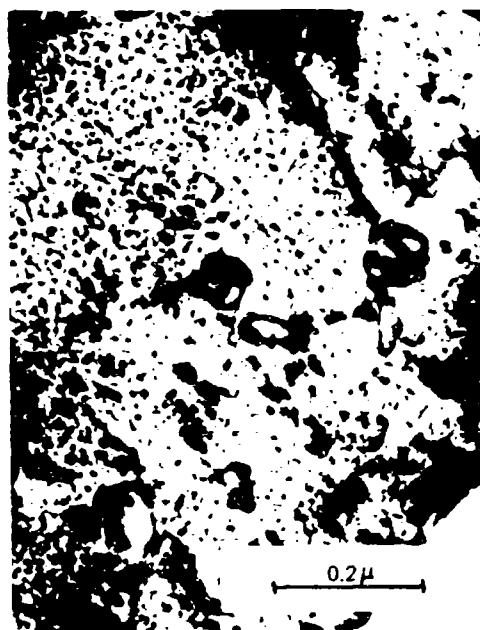
Figure 8. Typical Microstructures (Transmission Electron Micrographs)

Transmission electron micrographs of the Phase II alloys and of comparison alloys 7079-T6-G, 7575, AZ74.61, 7075-T73, X7080-T7, and 7178-T76 are shown in Fig. 8. The 7075-T651-1 and 7079-T6-G contain the small, spherical zone-type precipitates primarily, whereas the other alloys exhibit larger and (in some cases) more plate-shaped precipitates of the M' phase, reflecting their more overaged condition. In the silver-bearing alloy 17, coherency strain fields are visible around some of the M' plates. Alloy 18 appears less overaged than alloys 16, 17, 19, and 20 but is further along in the aging sequence than 7075-T651-1 or 7079-T6-G. Like the photomicrograph in Fig. 4, the transmission electron micrograph of alloy 18 (Fig. 8C) shows no chromium-rich intermetallic particles. The other low-chromium alloy X7080-T7, also contains a low density of the small intermetallic phases. The exact heat treatment given the X7080-T7 is unknown, but from the appearance of the precipitates this alloy appears to be more overaged than alloy 18. Conductivity readings for these two alloys also indicate that this is the case. Alloy 7075-T73 is more overaged than the Phase II base alloy 16, but this is not apparent from the transmission electron micrographs. The presence of silver in the Phase II and comparison alloys has only a small effect on the microstructure, evidenced as a more plate-shaped M' precipitate. Precipitate-free zones are present in both silver-free and silver-bearing alloys.

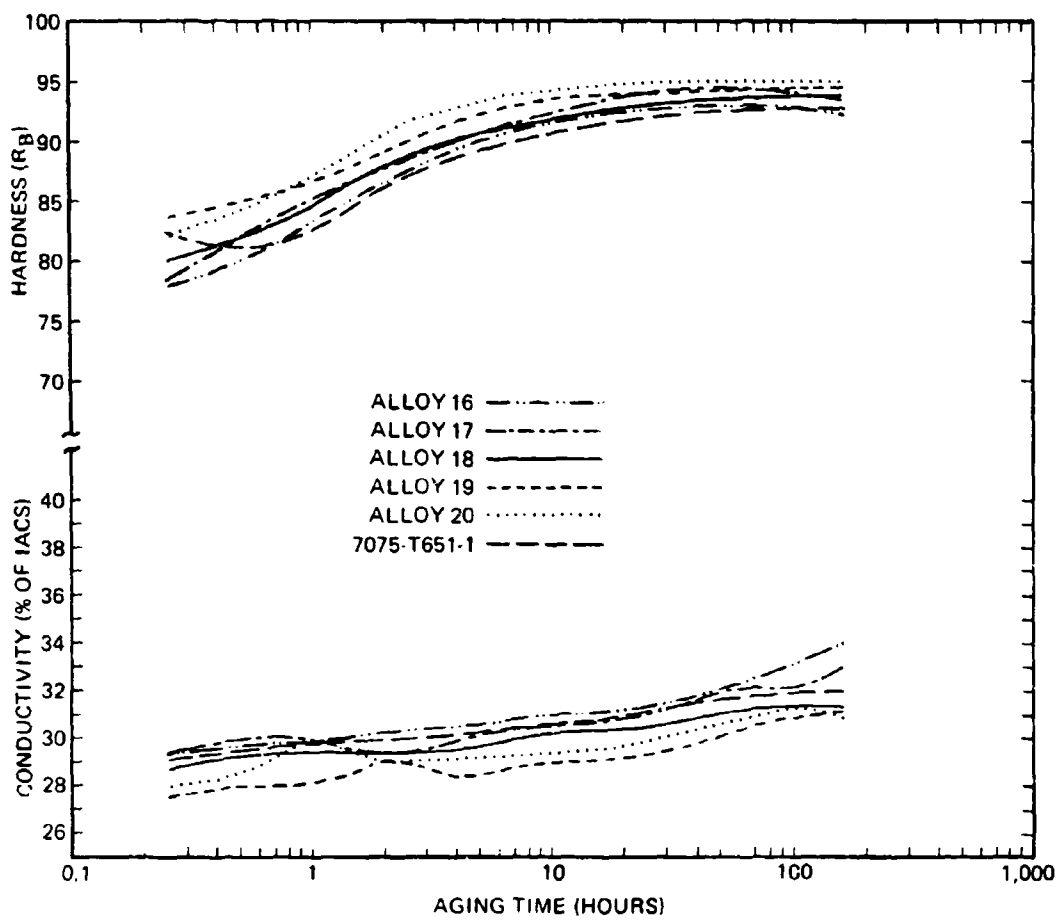
Aging studies were conducted on the Phase II alloys, using hardness and conductivity measurements. Figure 9 shows curves for aging at 250°F. The silver addition increases hardness values in the T6 condition (24 hr at 250°F). (Compare alloys 16 and 17.) The higher copper content in alloy 19 and the higher zinc and magnesium contents in alloy 20 also result in higher hardness in the T6 condition. (Compare alloys 19 and 20 with 17.) All Phase II alloys show higher hardness than 7075 up to an aging time of approximately 100 hr at 250°F. Replacement of chromium with zirconium reduces conductivity, as do the higher zinc and magnesium contents and the higher copper content. (Compare alloys 18, 19, and 20 with alloy 17.)

Figure 9. Aging Behavior at 250° F after 2 Hours at Room Temperature

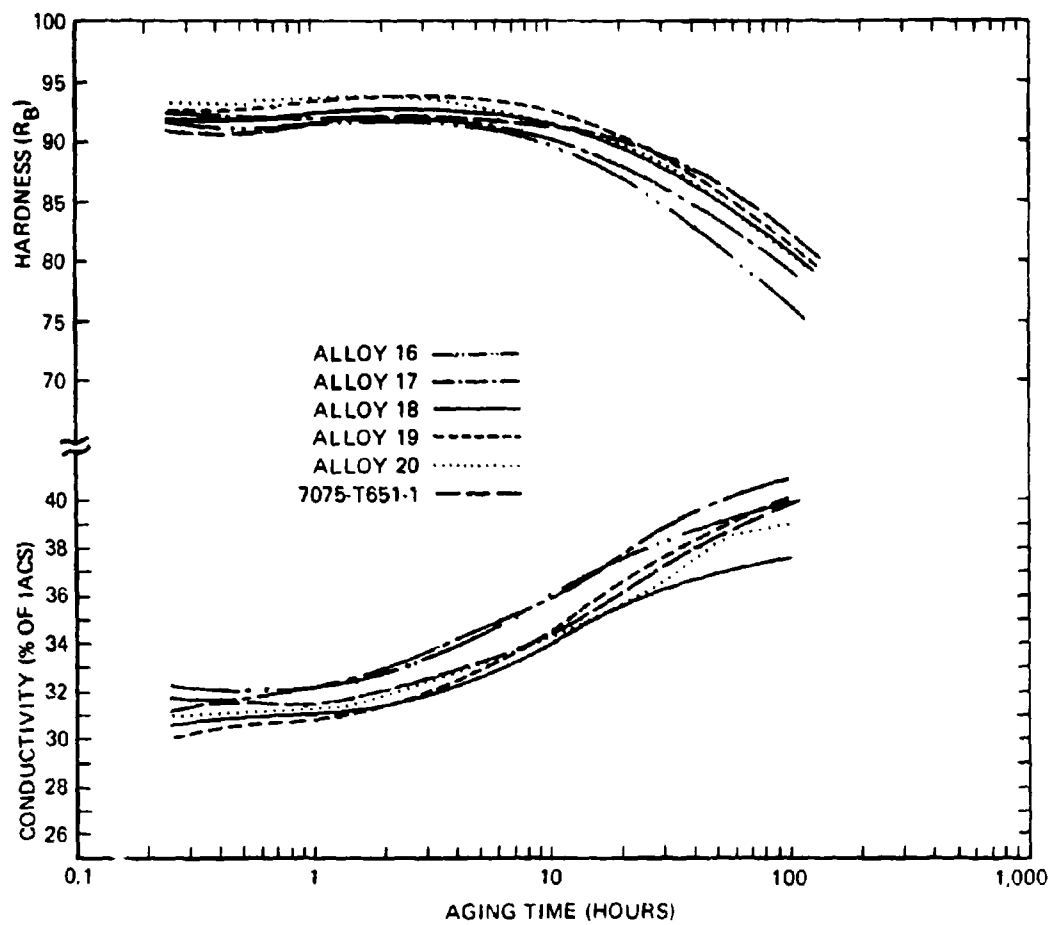
Figure 10 shows aging curves at 320°F after a T6-type treatment. After a few hours initial aging at 320°F the silver-bearing alloy has a higher hardness than the silver-free alloy for any given aging time. After 10 hr at 320°F the difference between alloy 16 (silver-free) and alloy 17 (silver-bearing) is one  $R_p$  point; after 100 hr at 320°F the difference is three  $R_p$  points. This difference, though small, increases steadily as the aging time increases, indicating that the effect of silver on strength is more pronounced at the longer aging times. Alloys 16 and 17 have lower hardness values than any other Phase II alloys for any given aging time. The hardness data show that the higher-copper alloys (19 and 7075-T651-1) have the highest hardness beyond 24 hr at 320°F.

Figure 10. Aging Behavior at 320°F after 2 Hours at Room Temperature + 24 Hours at 250°F

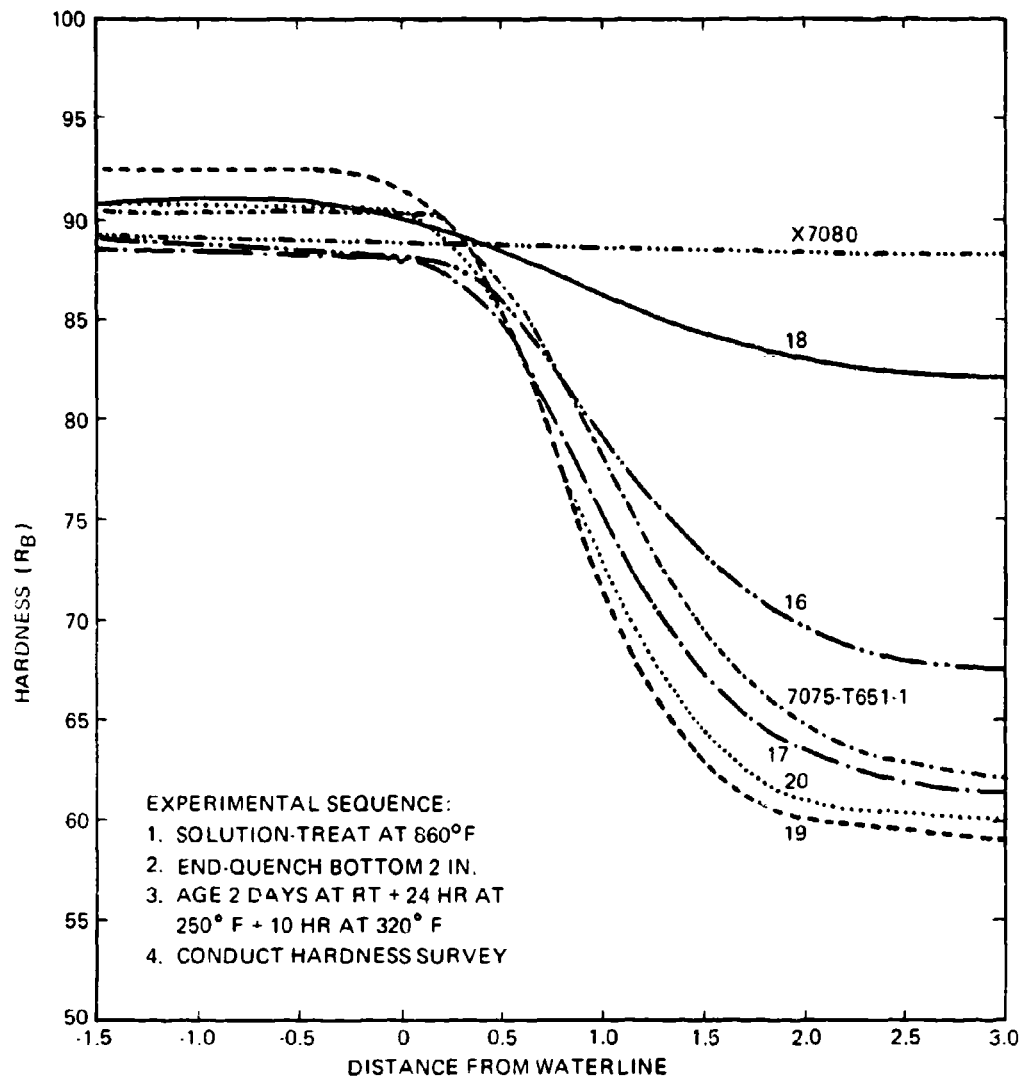
Figure 11. Quench Sensitivities of Phase II Alloys and X7080

The yield strength of X7080-T7 is similar to that of 7075-T73; the average of seven specimens was 61.4 ksi. Tensile specimens of X7080-T7 were taken at several depths through an 8-in.-thick die forging which had been quenched in boiling water. The mechanical properties of this forging varied only slightly across its thickness. This would be expected on the basis of this alloy's composition (low chromium, low copper) and quench-sensitivity curve (Fig. 11).

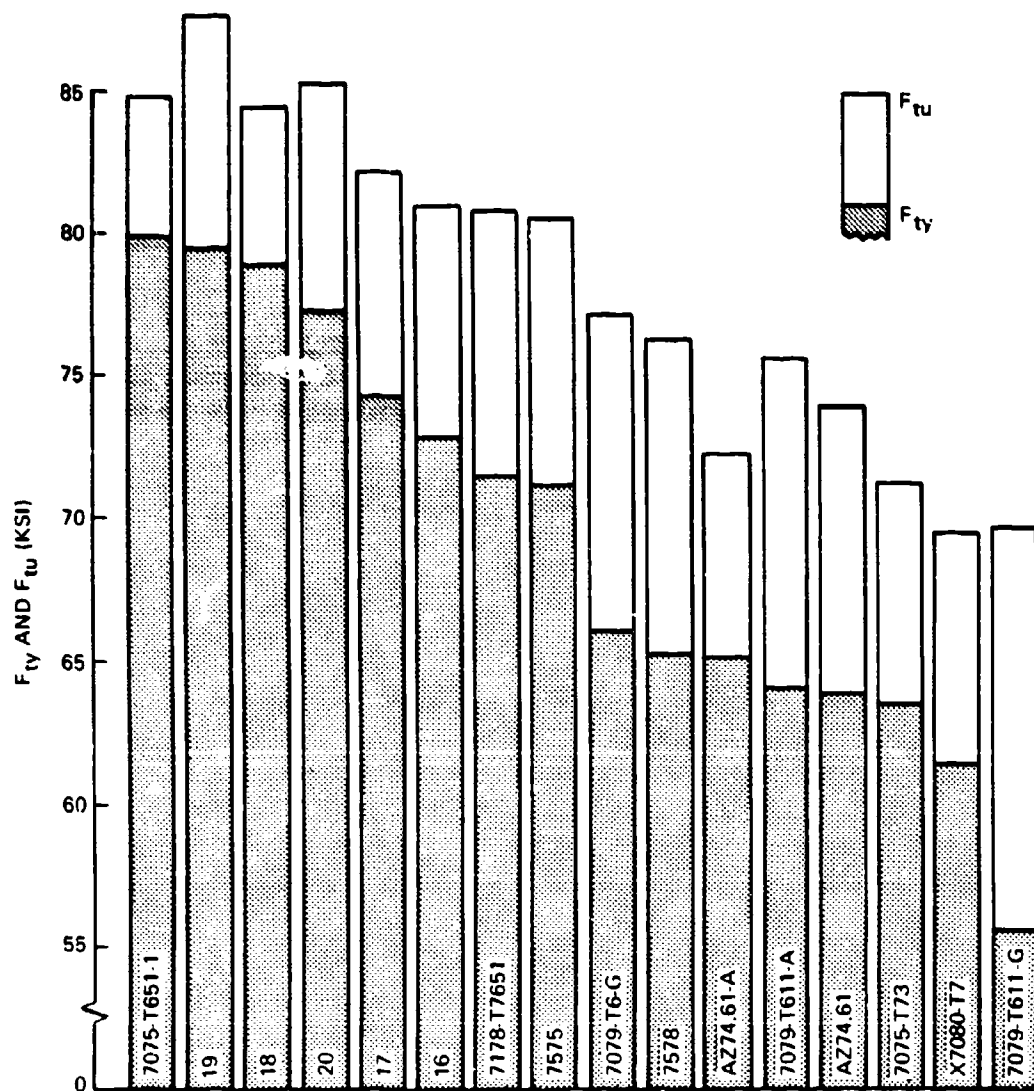
With few exceptions (7178-T7651, 7575, 7079-T6-G, and 7578), the longitudinal yield strengths decrease in the same relative order as the as-received hardness values noted in Table I. The transverse mechanical properties are slightly lower than the longitudinal properties for all Phase II alloys except 16. It is not clear why alloy 16 behaves differently.

The silver addition in alloy 17 produces a small increase in yield strength (1.5 ksi) over that of alloy 16, in the longitudinal direction. Transverse mechanical properties of alloys 16 and 17 are nearly identical. Increased zinc and magnesium contents in alloy 20, replacement of chromium with zirconium in alloy 18, and increased copper content in alloy 19 all increase the strength above that of alloy 17. All Phase II alloys have yield strengths above the 70,000-psi goal and show higher strengths than any of the comparison alloys.

Figure 12. Longitudinal Mechanical Properties (Plotted in order of decreasing yield strength)

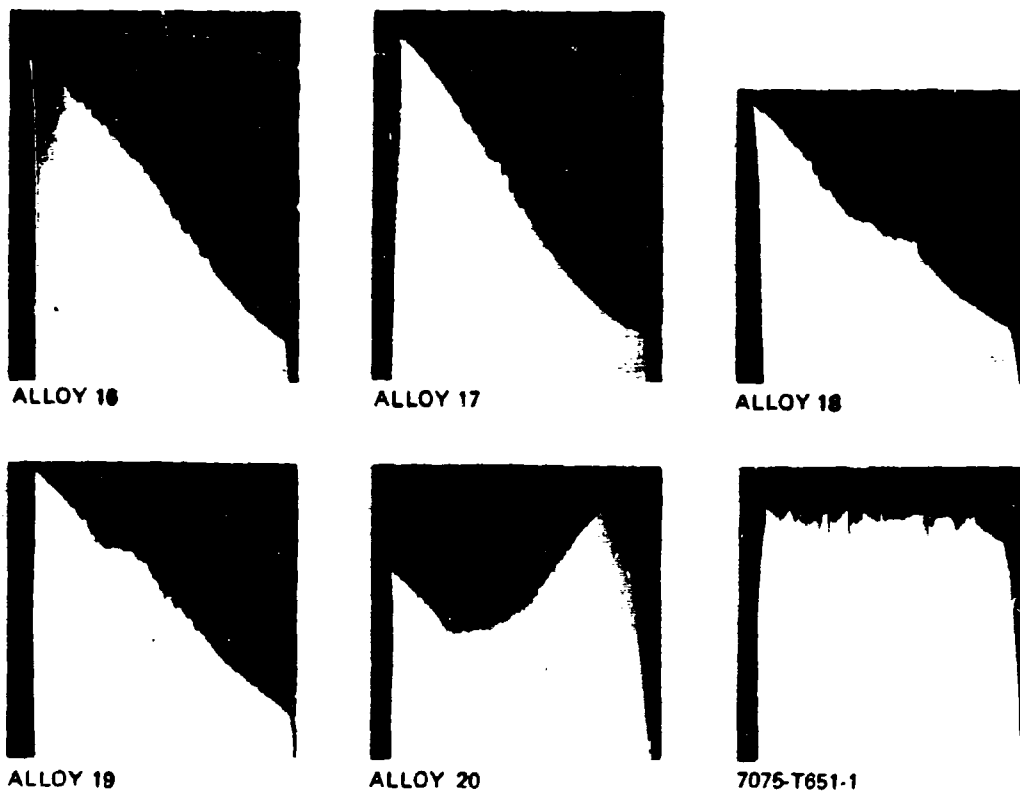
- a. The 7075-T651-1 showed much more intergranular short-transverse delamination or "splitting" on the fracture faces than did any of the overaged Phase II alloys. This difference is illustrated in Fig. 13, which shows the fracture surfaces of typical precracked Charpy specimens, and Fig. 14, which shows fracture profiles of typical center-notched panels taken 0.25 in. from the panel ends.
- b. Macroscopically, all Phase II alloys except 7075-T651-1 showed a nearly 100-percent shear-mode fracture in the center-notched panels (Fig. 14). 7075-T651-1 showed primarily a flat fracture mode.

*Figure 14. Fracture Profiles from Phase II Alloy Center-Notched Panels  
(Sectioned 0.25 in. from panel edge) (6x)*

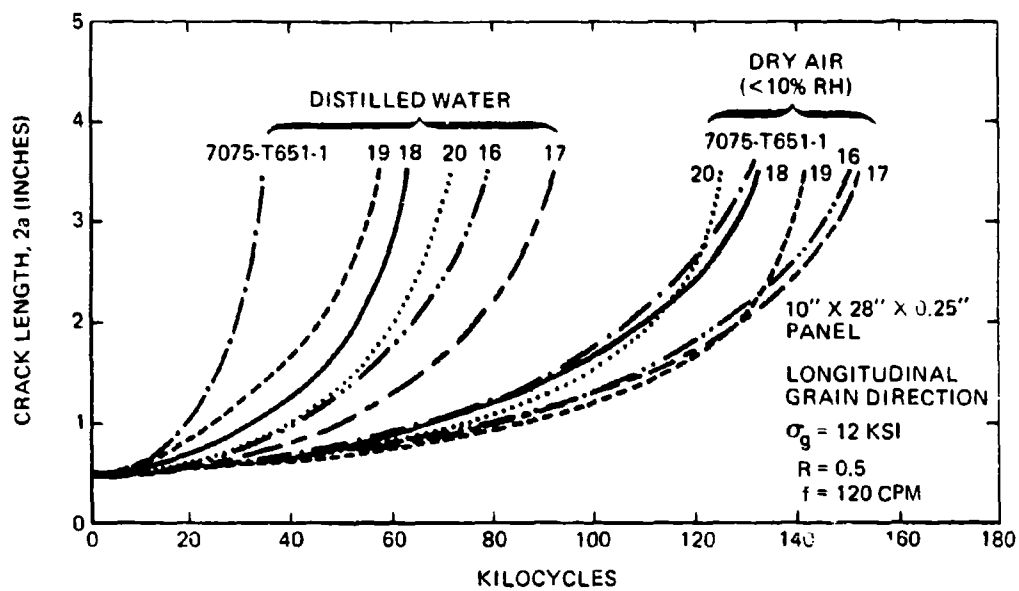
Figure 16 presents data on crack length versus cycles for each alloy and environment. Figure 17 is a plot of stress intensity factor  $K$  versus crack growth rate  $\Delta 2a/\Delta n$  for each alloy and environment. The slopes of the lines in Fig. 17 range from 2.4 (alloy 19 in distilled water) to 4.4 (alloy 19 in dry air).

Figure 16. Fatigue-Crack Propagation Curves for Phase II Alloys

The difference between the overaged Phase II alloys and the peak-aged 7075-T651-1 is more pronounced in distilled water. In this environment all overaged Phase II alloys require two to three times as many cycles as the peak-aged 7075-T651-1 to propagate cracks from 0.5 to 3.5 in. Other comparisons noted in the number of cycles required for propagation from 0.5 to 3.5 in. are the following:

- a. The silver addition in alloy 17 increases the number of cycles about 16 percent in comparison with alloy 16;
- b. Replacement of chromium with zirconium in alloy 18 reduces the number of cycles about 32 percent in comparison with alloy 17;
- c. Increasing the copper content in alloy 19 reduces the number of cycles about 38 percent in comparison with alloy 17;

- d. Increasing the zinc and magnesium contents in alloy 20 reduces the number of cycles about 24 percent in comparison with alloy 17.

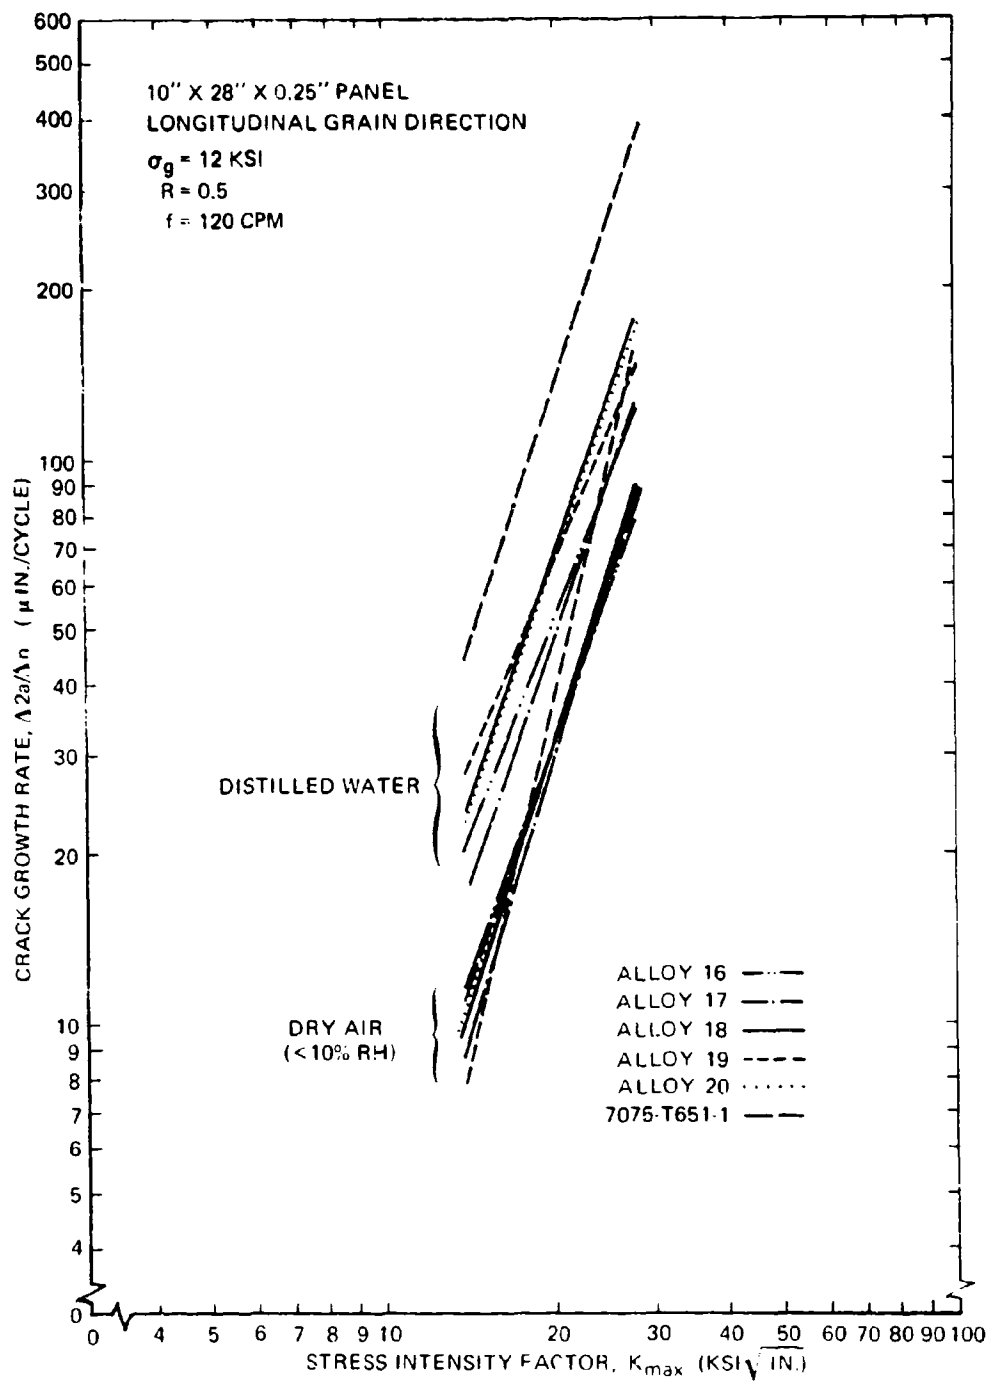
Figure 17. Fatigue Crack Growth Rate Versus Stress Intensity for Phase II Alloys

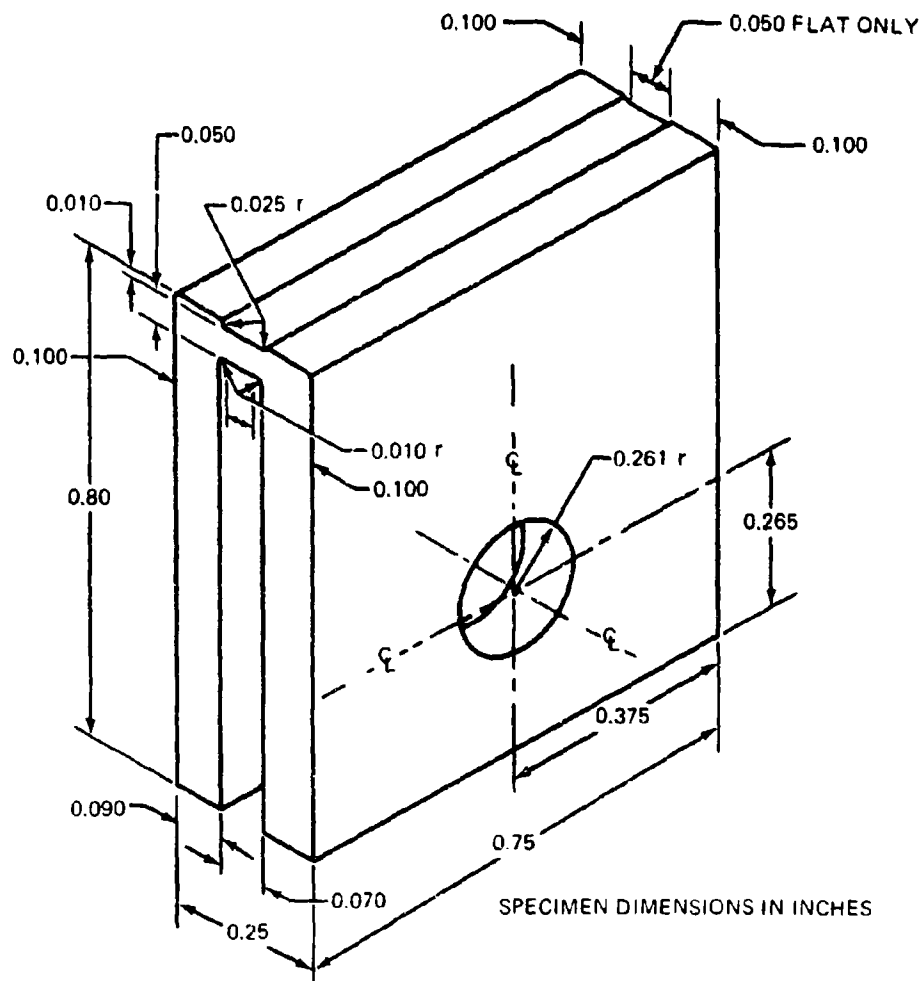
SHORT-TRANSVERSE STRESS, $\sigma$ (KSI)	LEG DEFLECTION, $\delta^*$ (IN.)
14	0.0065
20	0.0092
26	0.0120
32	0.0147
44	0.0203
56	0.0257

\* MEASURED AT BOTTOM OF LEG

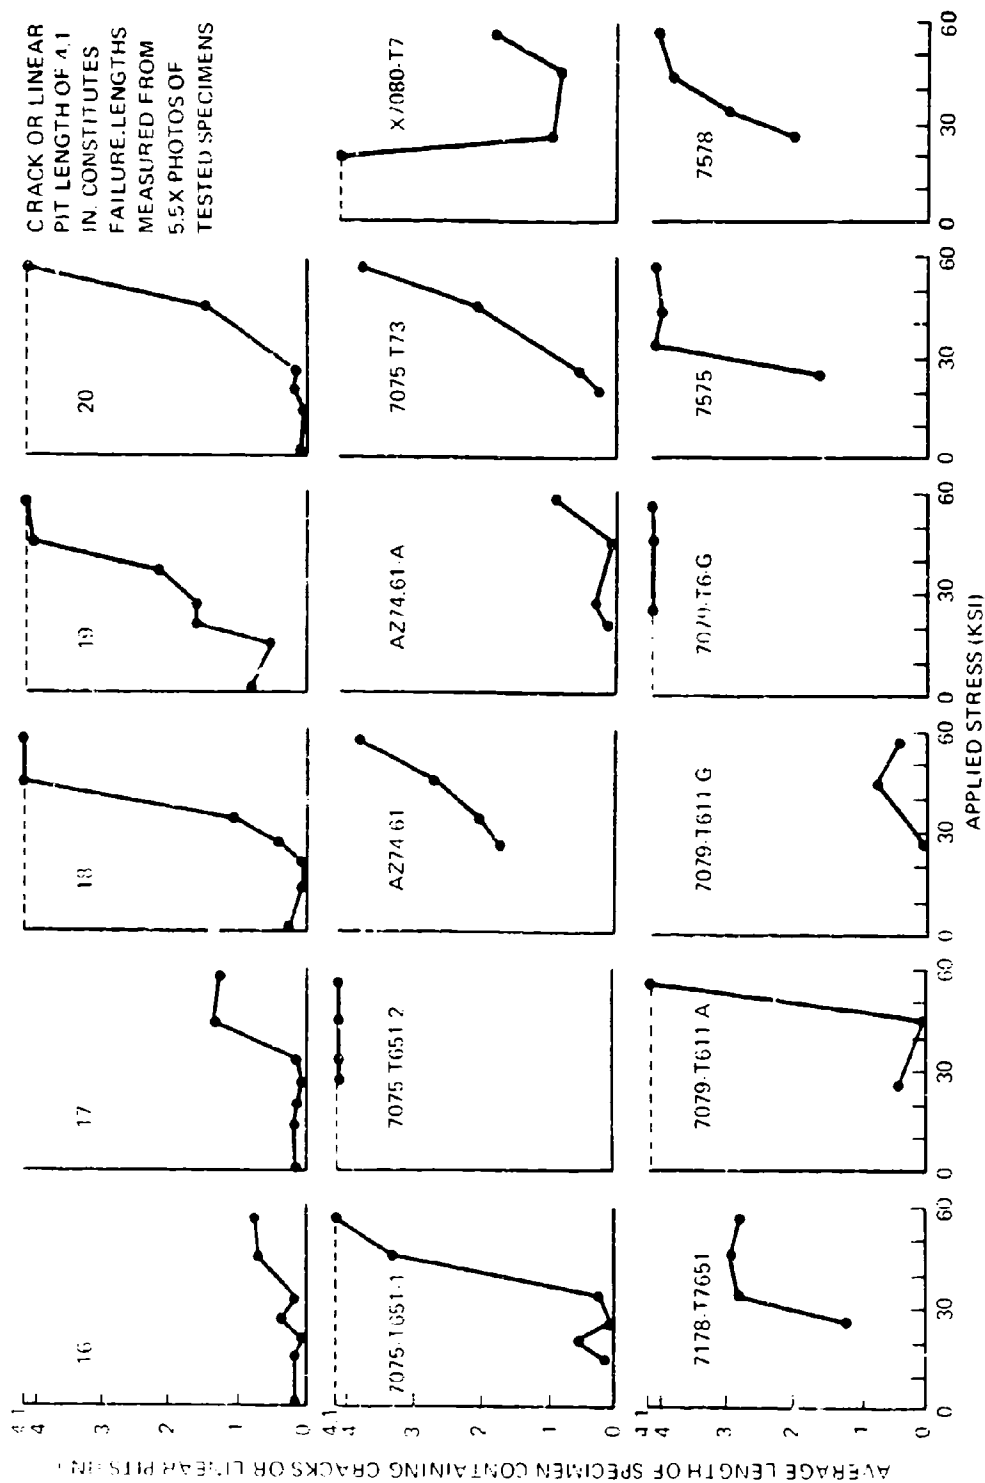
Figure 20. Extent of Cracking and Pitting on Phase II and Comparison Alloy Tested by Alternate Immersion in 3.5-Percent Sodium Chloride Solution

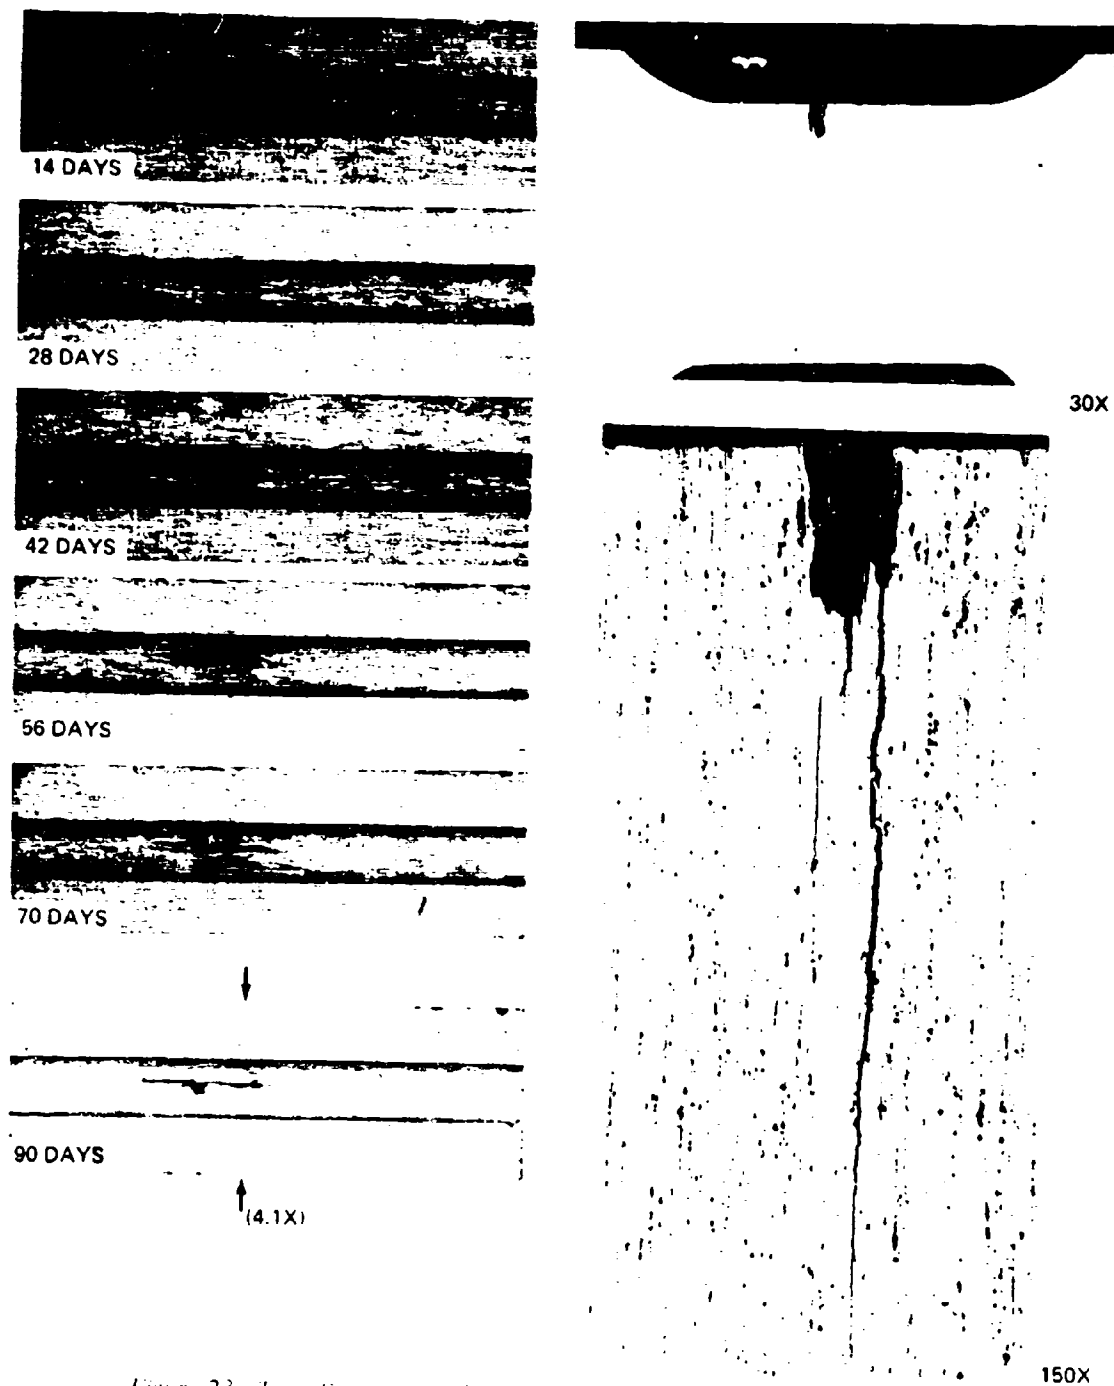
Alloy 16	Ranged from no attack to moderate linear pitting
Alloy 17	Minor pitting
Alloy 18	Linear pitting, sharp intergranular cracking; depth 0.035 in.
Alloy 19	General pitting and linear pitting, blunt intergranular protrusions; depth 0.006 in.

Figure 23. Time-Sequence and Cross-Section Photographs of 18-S at 26 KSI

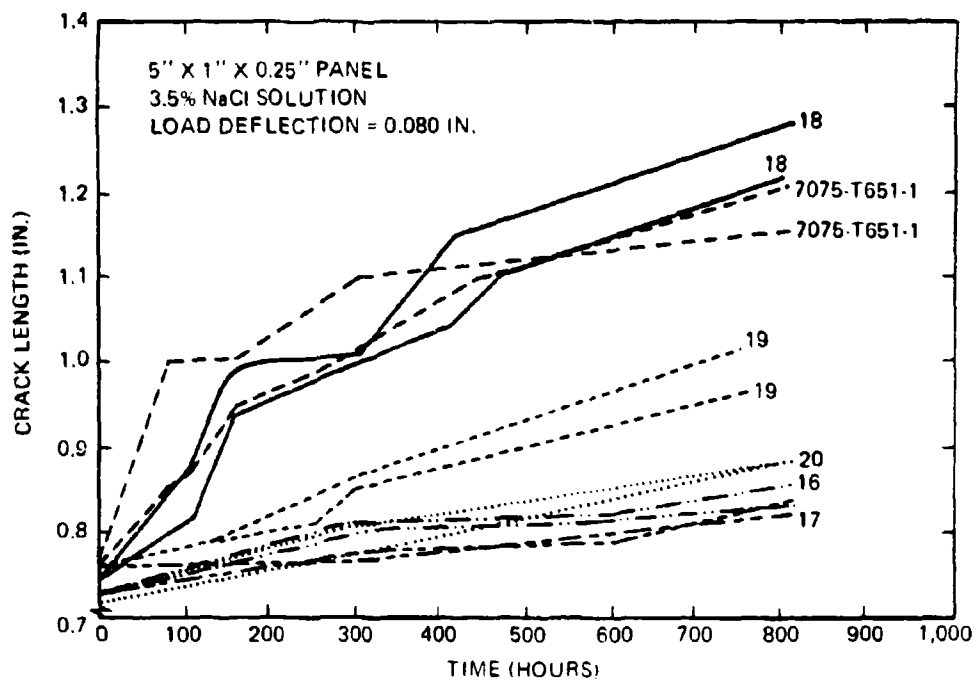
Figure 54. Stress-Corrosion Crack Propagation Curves for DCB Specimens

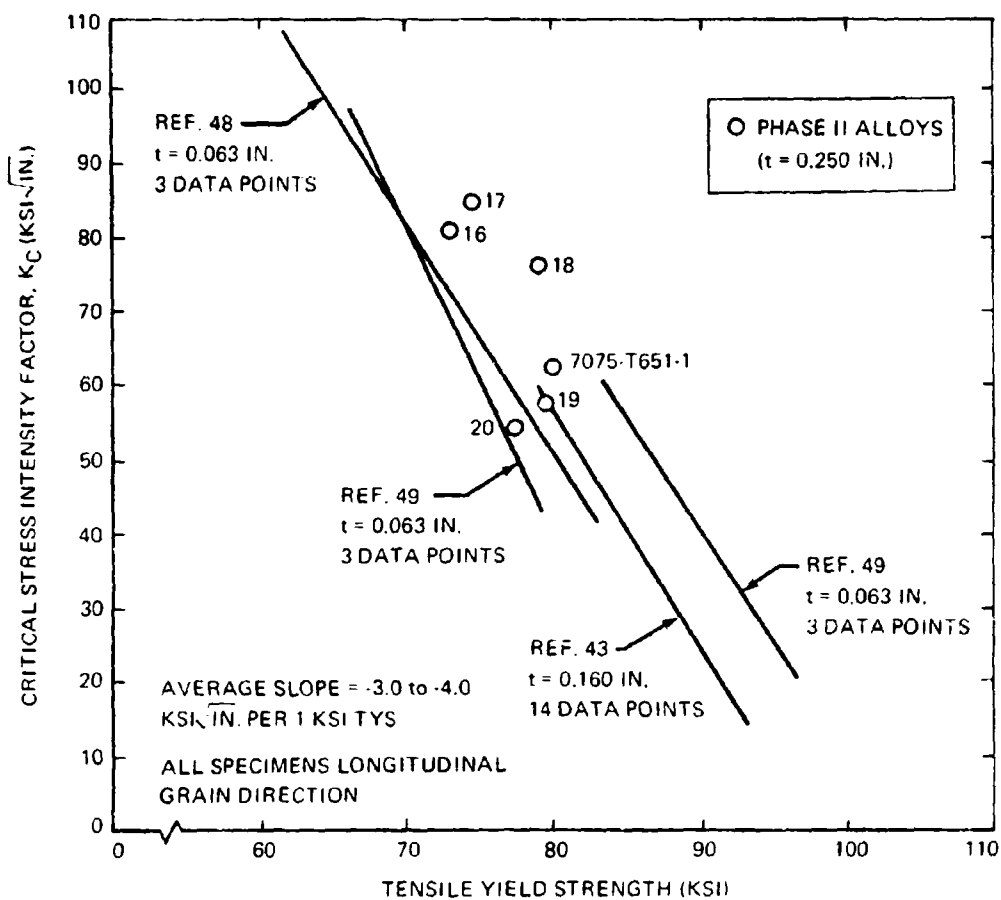
Figure 55. Fracture Toughness Parameter  $K_{IC}$  Versus Tensile Yield Strength for Several 7000-Series Aluminum Alloys

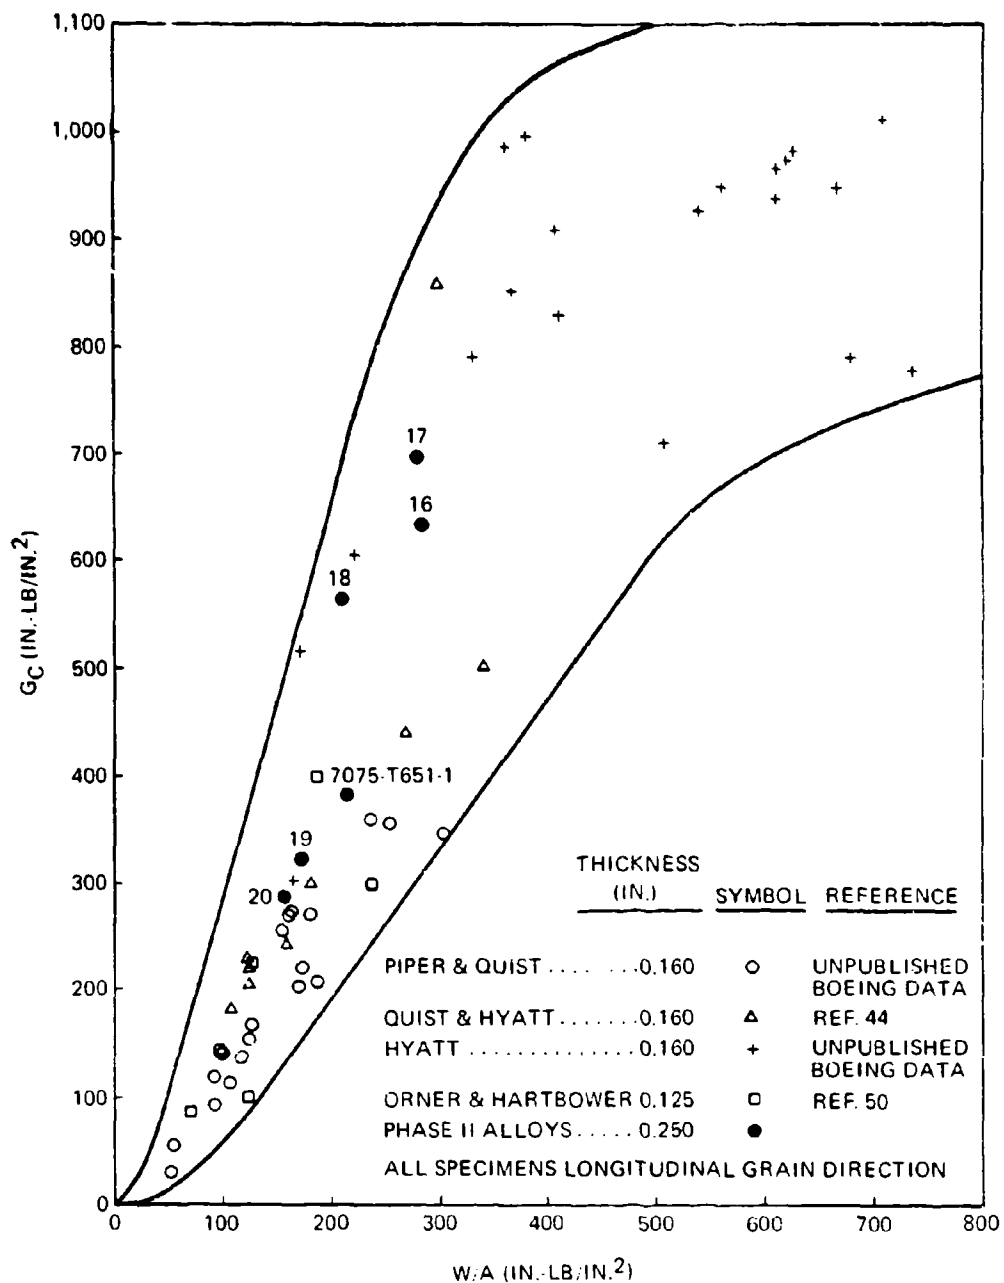
All Phase II alloys had higher  $W/A$  values than 7575, 7578, and 7178-T76, despite the fact that these alloys have lower strengths than any of the Phase II alloys. Charpy data indicate a  $K_{IC}$  of about  $41 \text{ ksi } \sqrt{\text{in.}}$  for 7178-T7651 at a yield strength of 71.5 ksi. The Phase II alloy with the lowest toughness had a  $K_{IC}$  of  $54.1 \text{ ksi } \sqrt{\text{in.}}$  at a yield strength of 77.3 ksi. The lower-strength comparison alloys X7080-T7 and AZ74.61 were tougher than the other comparison alloys and the Phase II alloy.

Figure 56. Correlation Between Precracked Charpy V-Notch Impact Data and  $G_c$  for Several 7000-Series Aluminum Alloys

An interesting possibility is that overaging may increase short-transverse fracture toughness. The short-transverse delaminations in the 7075-T651-1 fractures were intergranular, indicating that the material cannot sustain high stresses in the short-transverse direction without cracking along grain boundaries. Since these intergranular fractures are brittle, little energy is absorbed and the toughness is low. The important point is that overaging markedly reduces this tendency for short-transverse delamination.
